NA62 RICH STATUS REPORT

ASSEMBLY TOOLING - 1

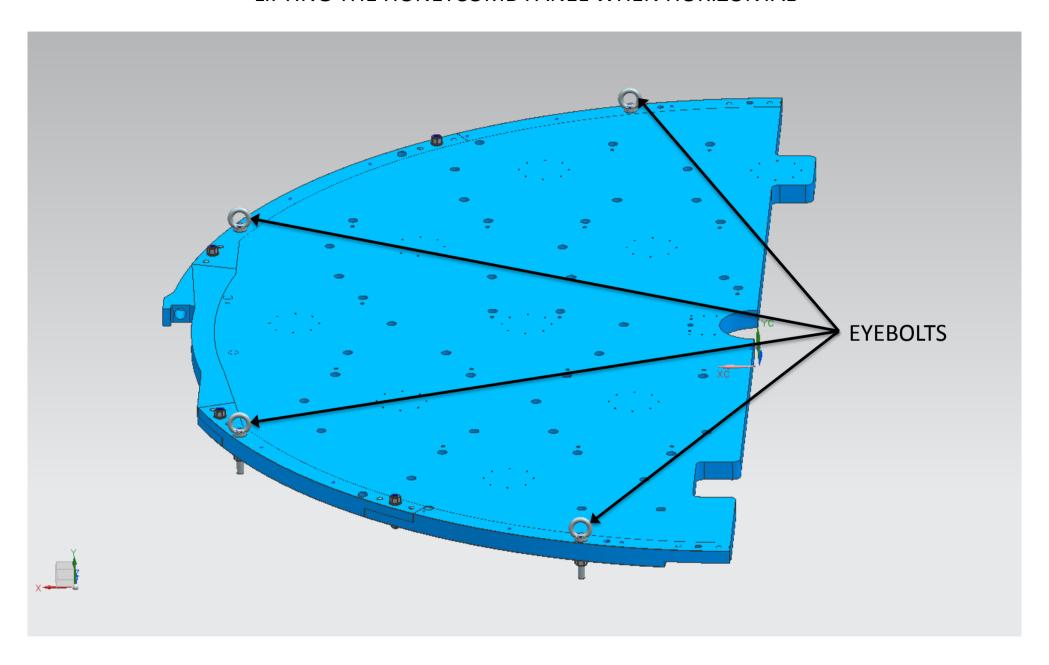
LIFTING THE HONEYCOMB PANEL WHEN HORIZONTAL

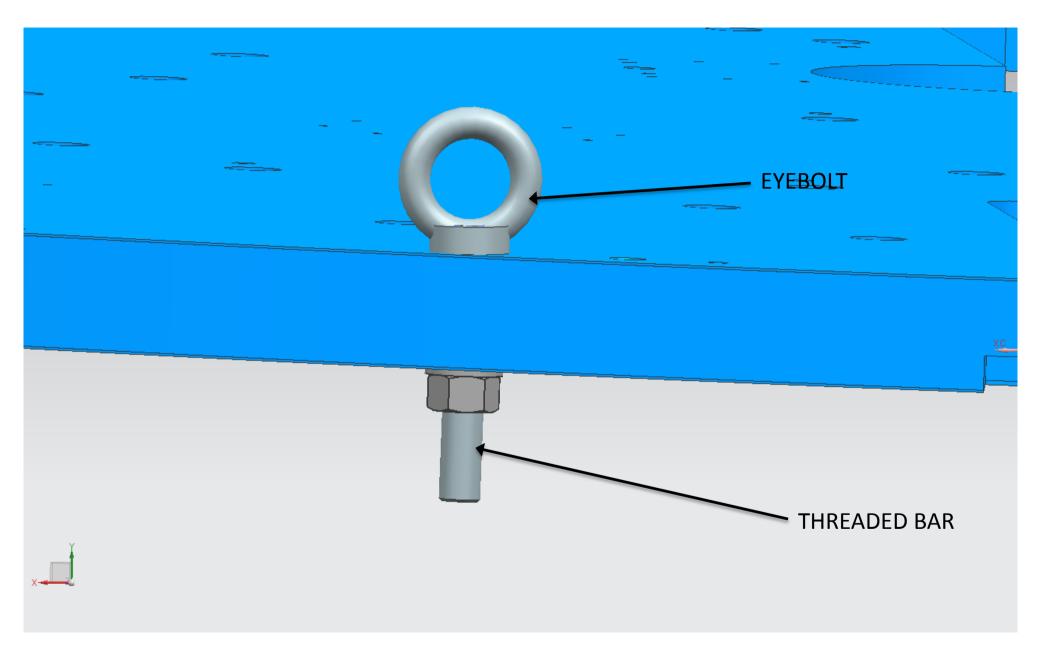
LIFTING THE HONEYCOMB PANEL WHEN HORIZONTAL - DETAIL

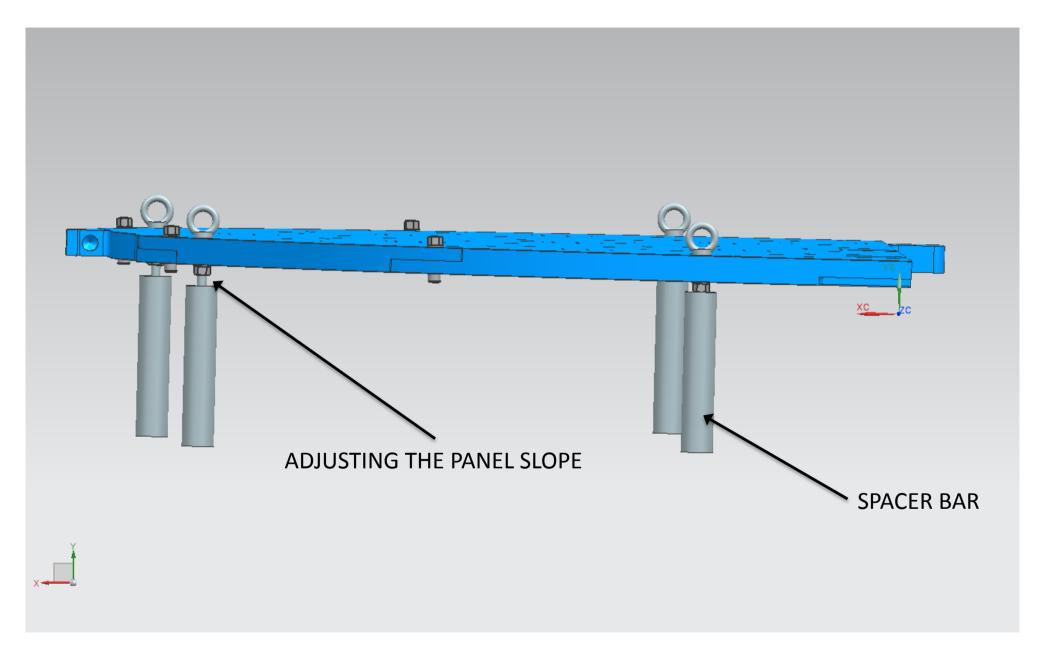
ADDING THE SPACER BARS

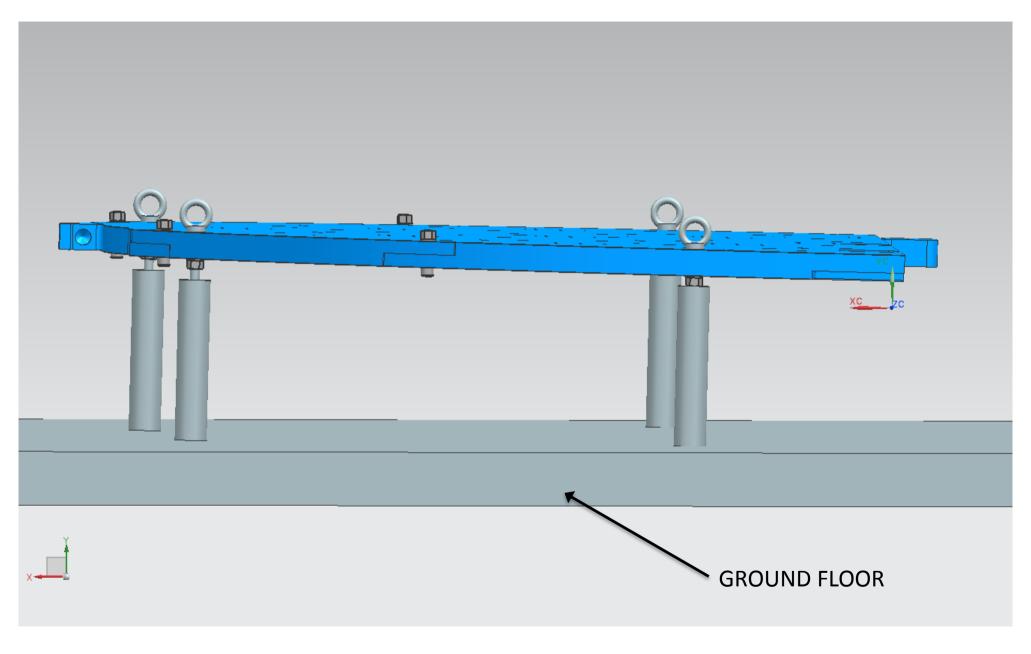
THE HONEYCOMB PANEL ON THE GROUND FLOOR

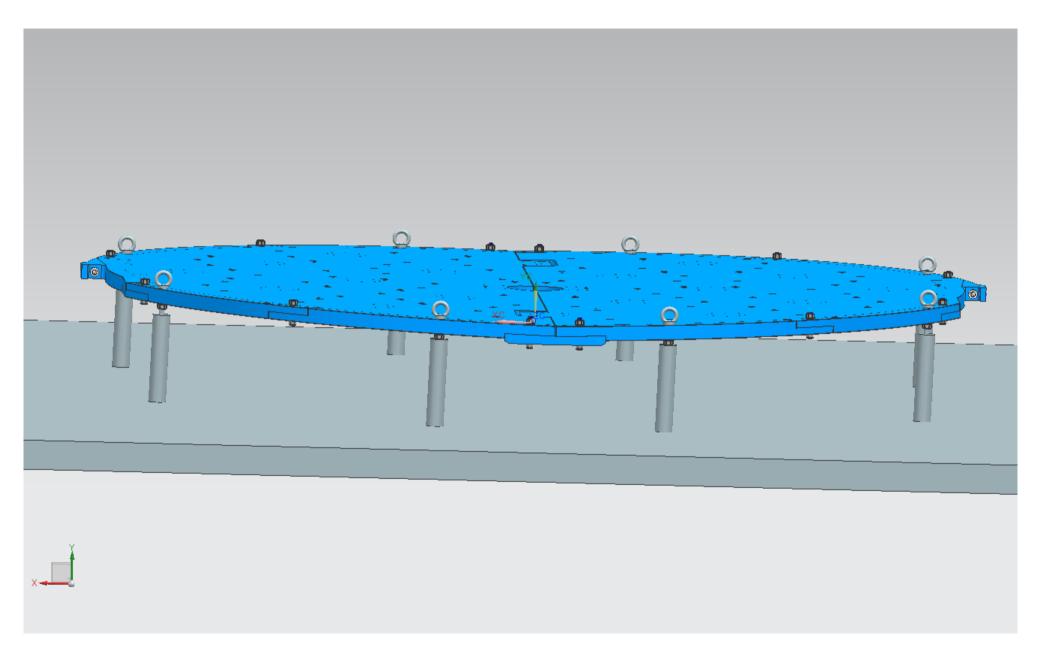
ASSEMBLING THE TWO HALF PANELS

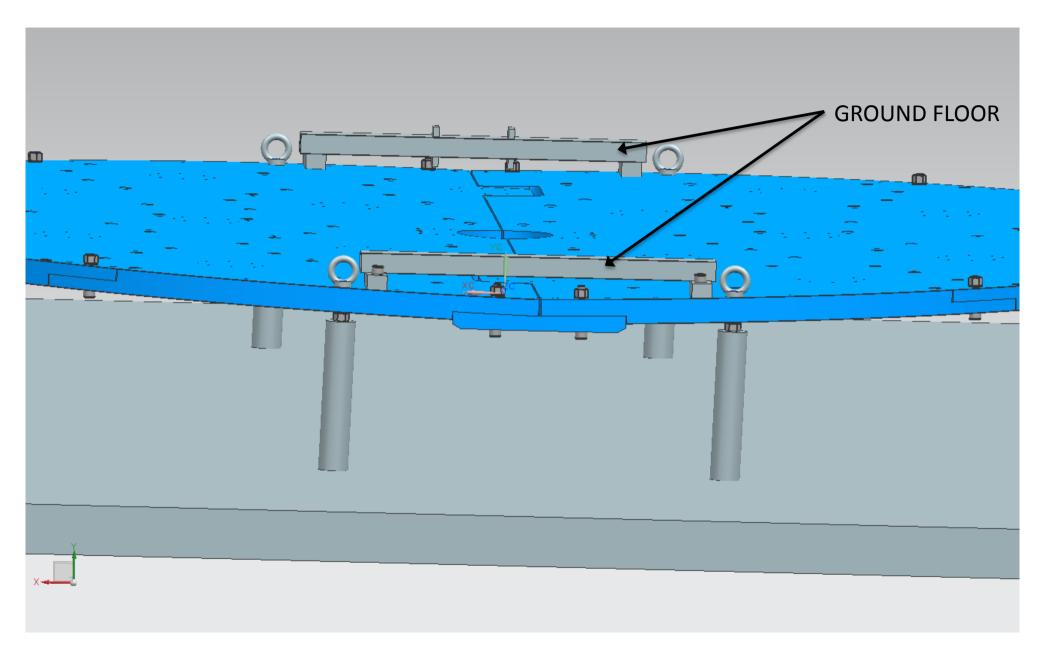
ADDING THE STIFFENING BARS

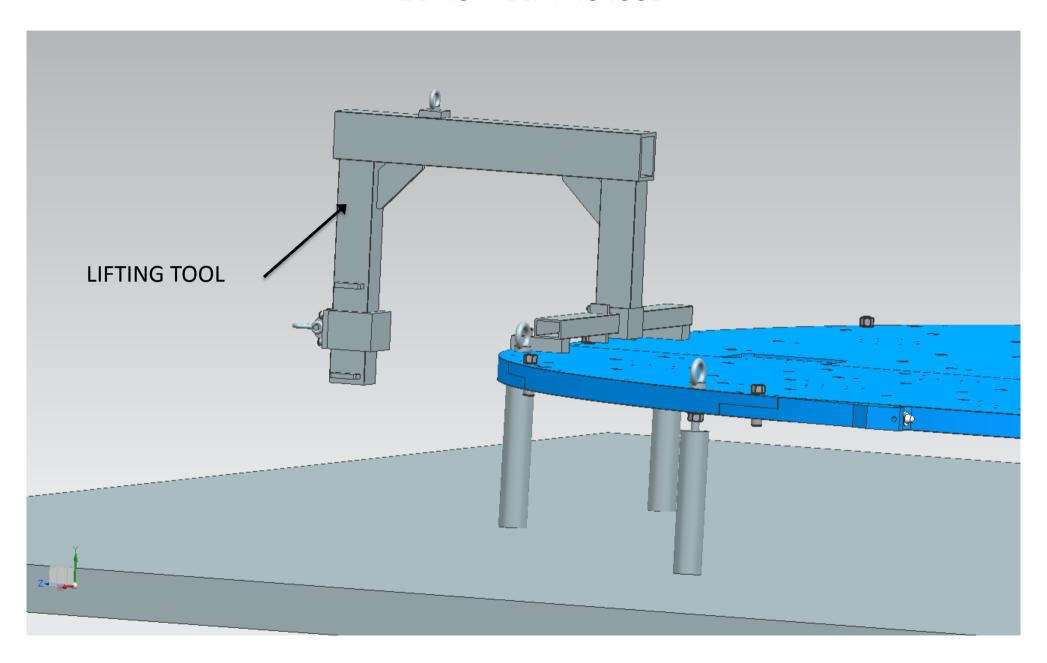
ADDING THE LIFTING TOOL

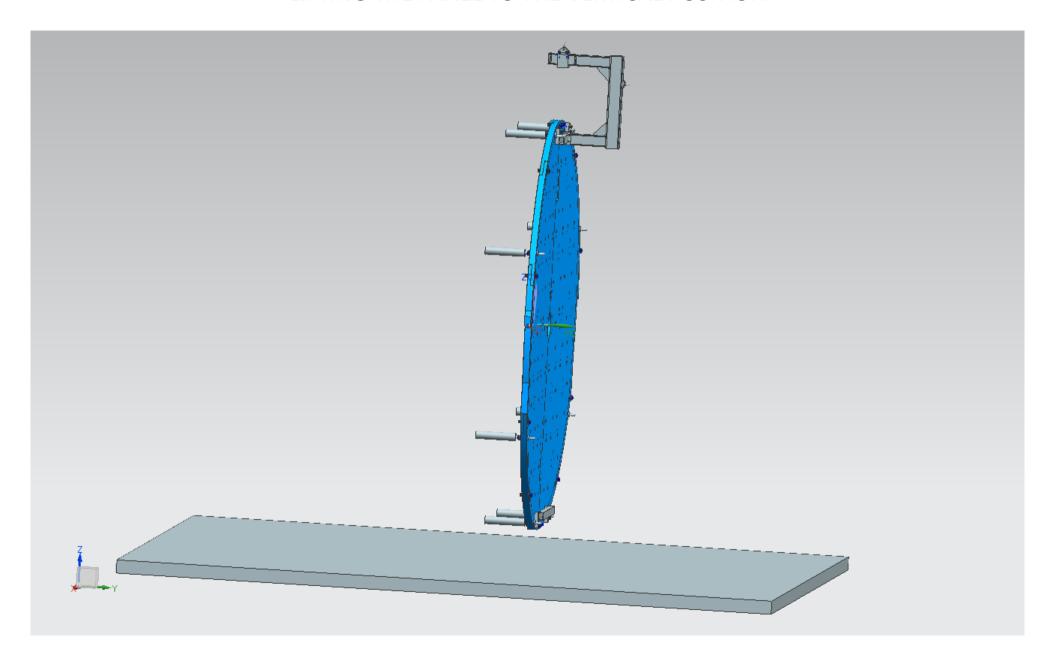
LIFTING THE PANEL TO THE VERTICAL POSITION

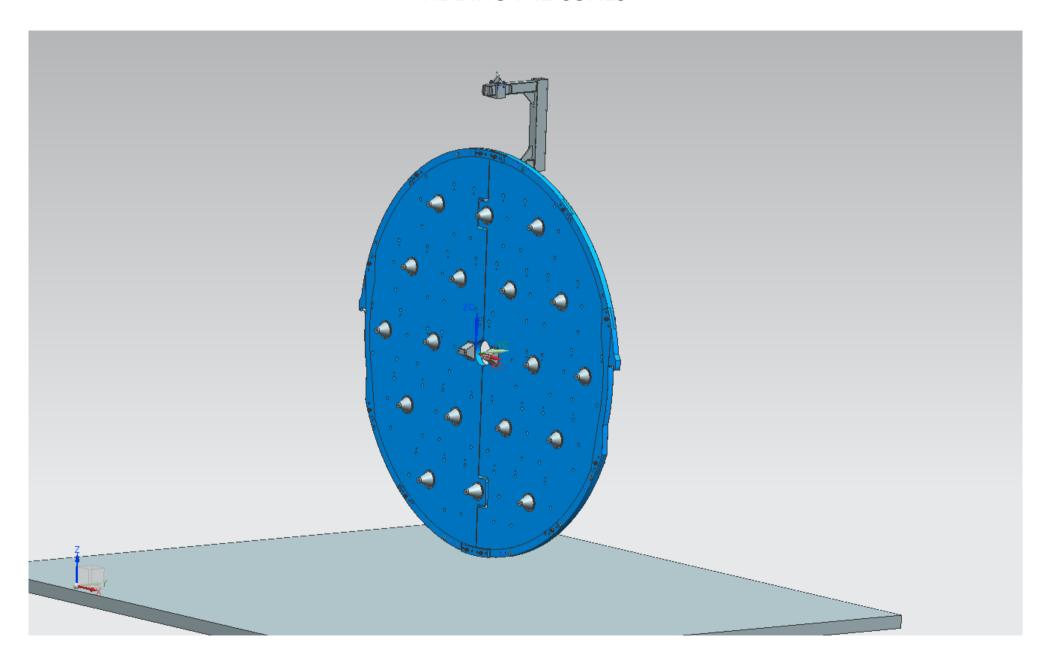
ADDING THE CONES
